Poorfarm Brook Large-Wood Restoration Project

Gilford, NH

Project Completion Summary

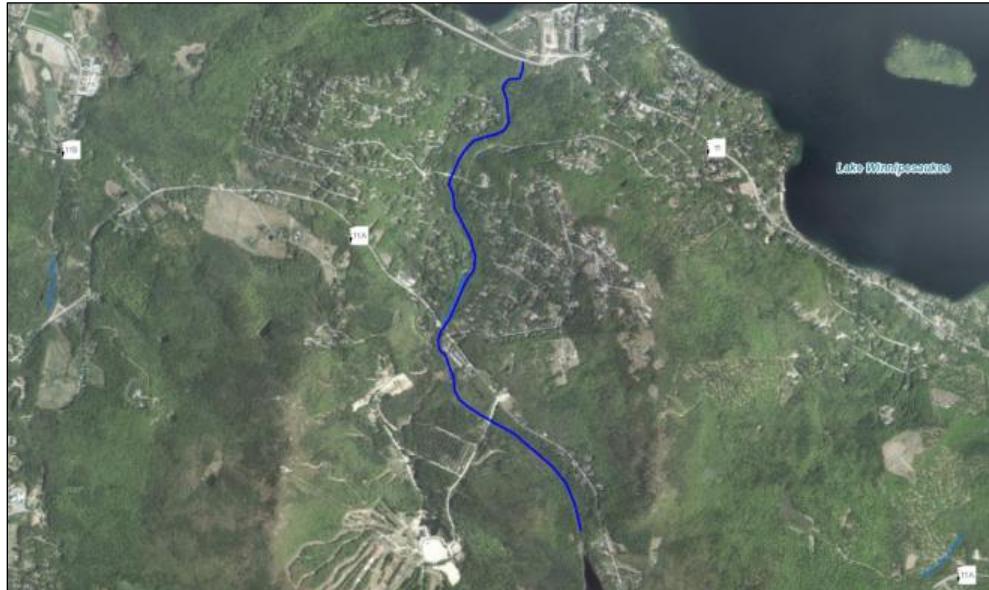
Project Area Map

The above map shows the entire 2.9-mile project reach of Poorfarm Brook, extending from the Gunstock reservoir dam to the Lake Shore Road (Rt. 11) crossing.

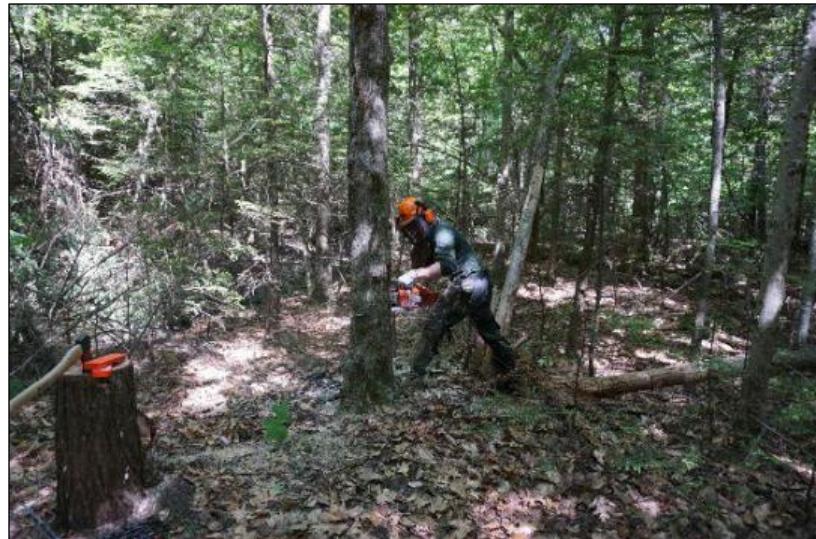
Team sawyer Joel DeStasio felling a tree into the stream channel.

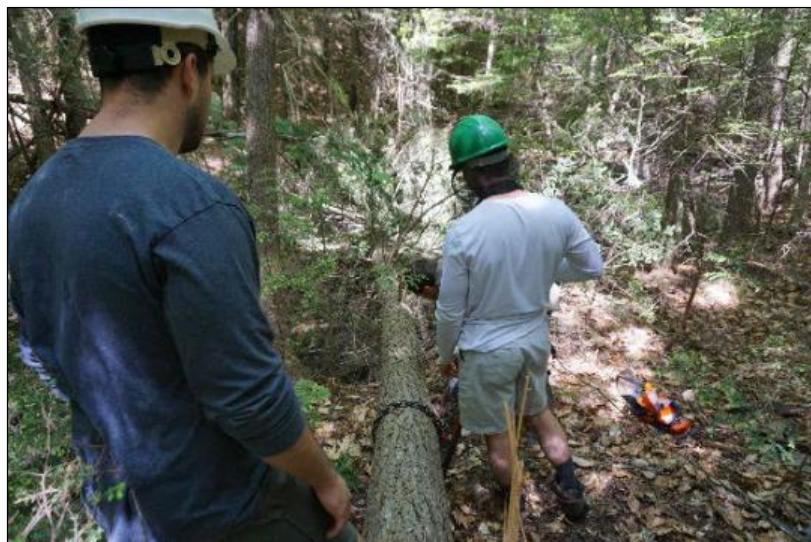
Field technicians Luca Trotta & Drew Dunlap setting up the grip hoist to move a felled tree into position.

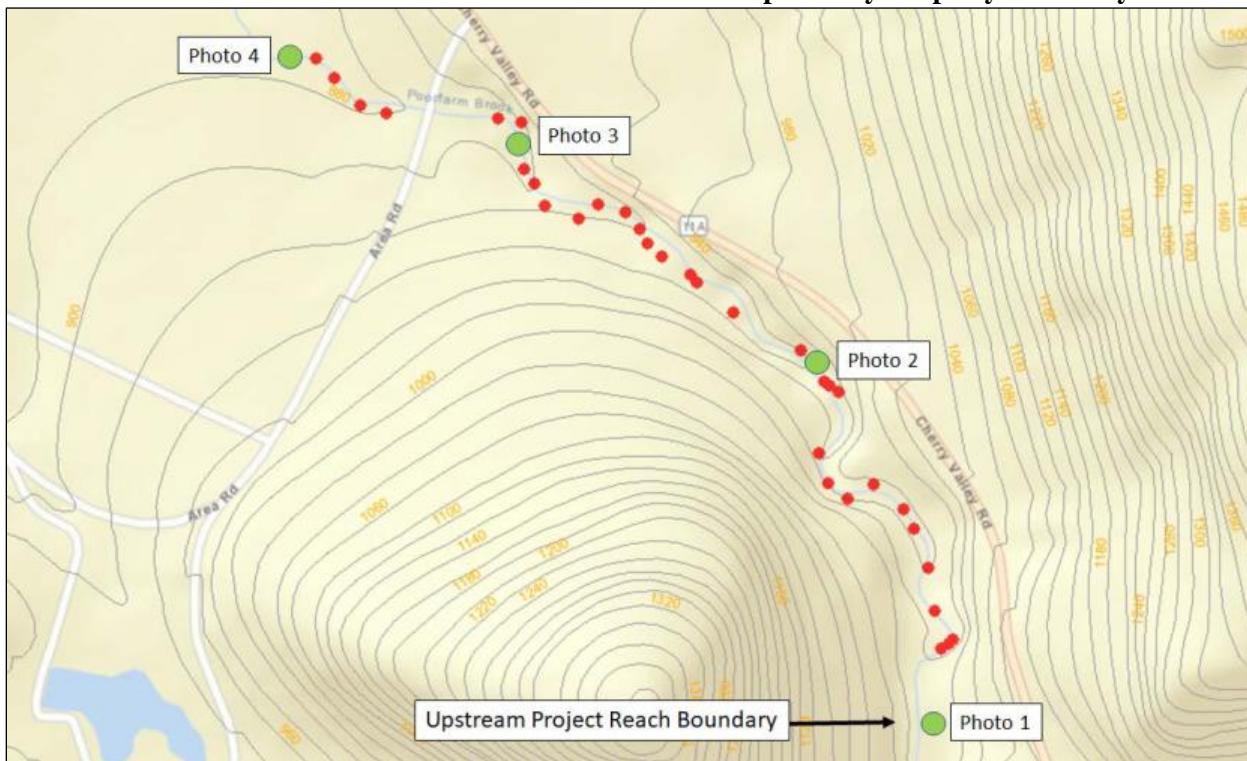
Reach 1: Gunstock Reservoir Dam to North-Western Belknap County Property Boundary

The above map shows the locations of installations 1-37 (red & green dots), located on the Belknap County (Gunstock ski resort) property reach of Poorfarm Brook. Green dots correspond to the below photographs.

This 6,300-foot reach of Poorfarm Brook is located on the Belknap County (Gunstock Ski Resort) property, with an average bankfull width of 23.4 feet. Along this reach, a total of 37 large-wood structures were installed, using trees with an average diameter at breast height (DBH) of 18.4cm. With concern regarding the possibility of wood mobilization during high-flow events within this section of Poorfarm Brook, large-wood structures were not installed within 500 feet upstream of the Panorama Drive (Gunstock entrance road) crossing. Added large-wood to this reach will encourage the formation and deepening of pools and scour banks, which are used by fish as refuge from high water velocities and shelter from overhead predators. Additionally, added large-wood to the lower section of this reach will facilitate reengagement with overflow chutes, which will decrease water velocities during high-flow events as well as reengagement with surrounding floodplains. Hiking/snowshoeing trails that run along a large portion of this reach will provide easy access for future monitoring of added large-wood.

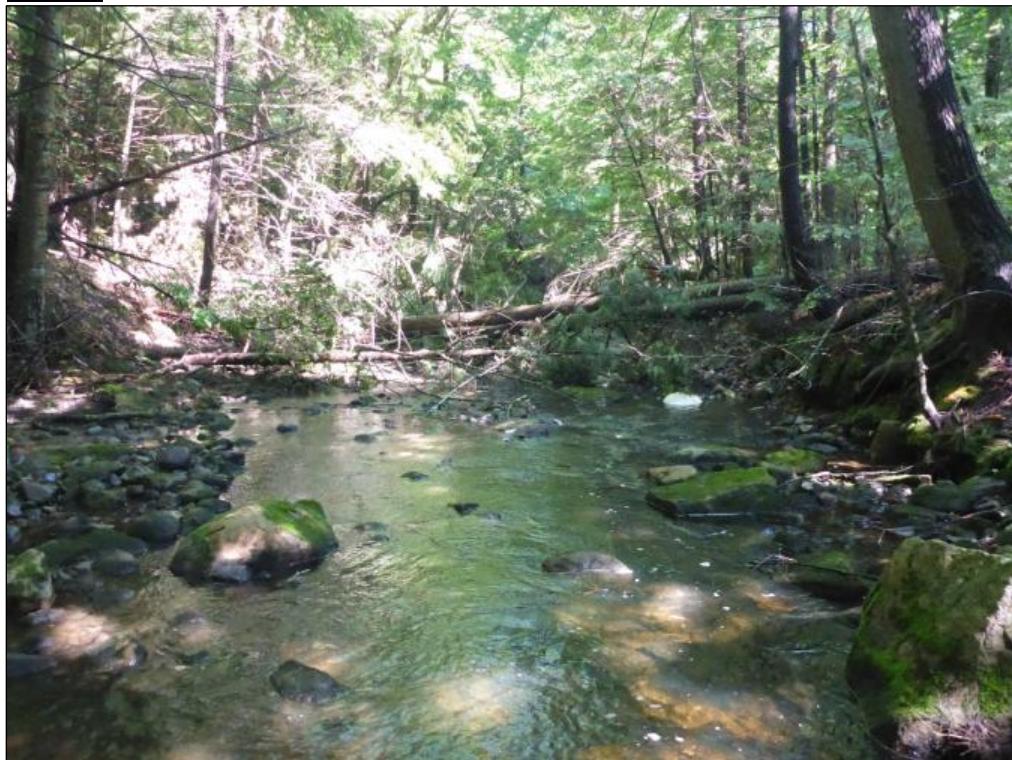
Photo 1:

Installation Site 1: N 43.54228°, W -71.35165°. Three eastern hemlocks were added to this location.

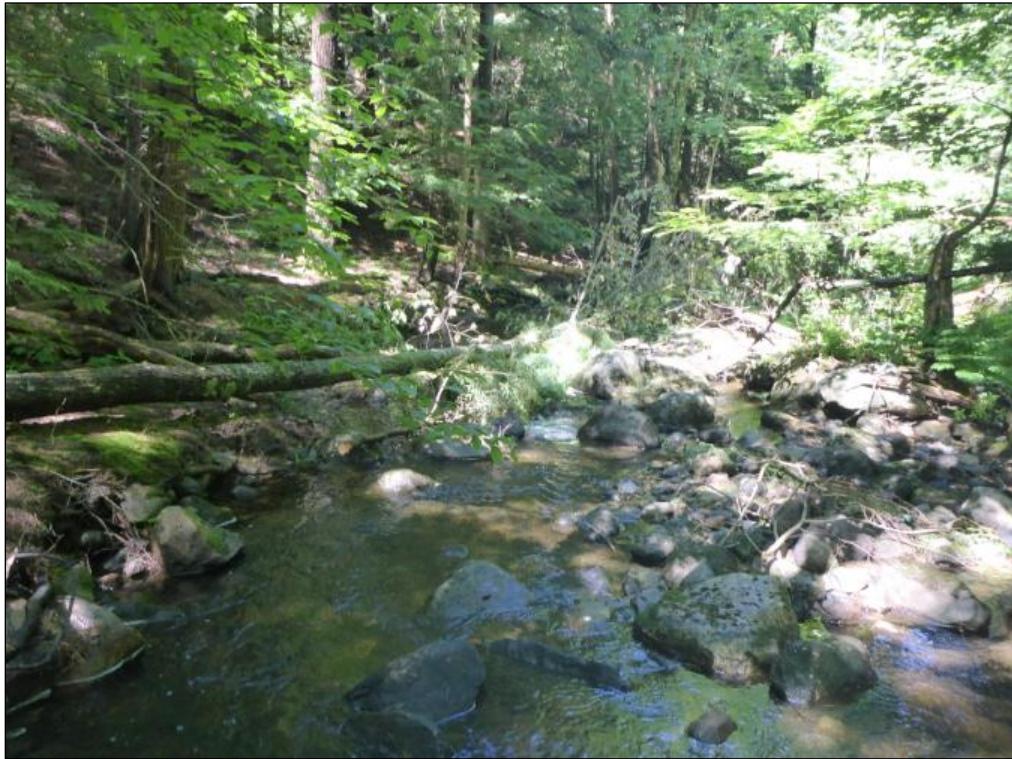
Photo 2:

Installation Site 16: N 43.54673°, W -71.35358°. One eastern hemlock, one beech, and one red maple were added to this location.

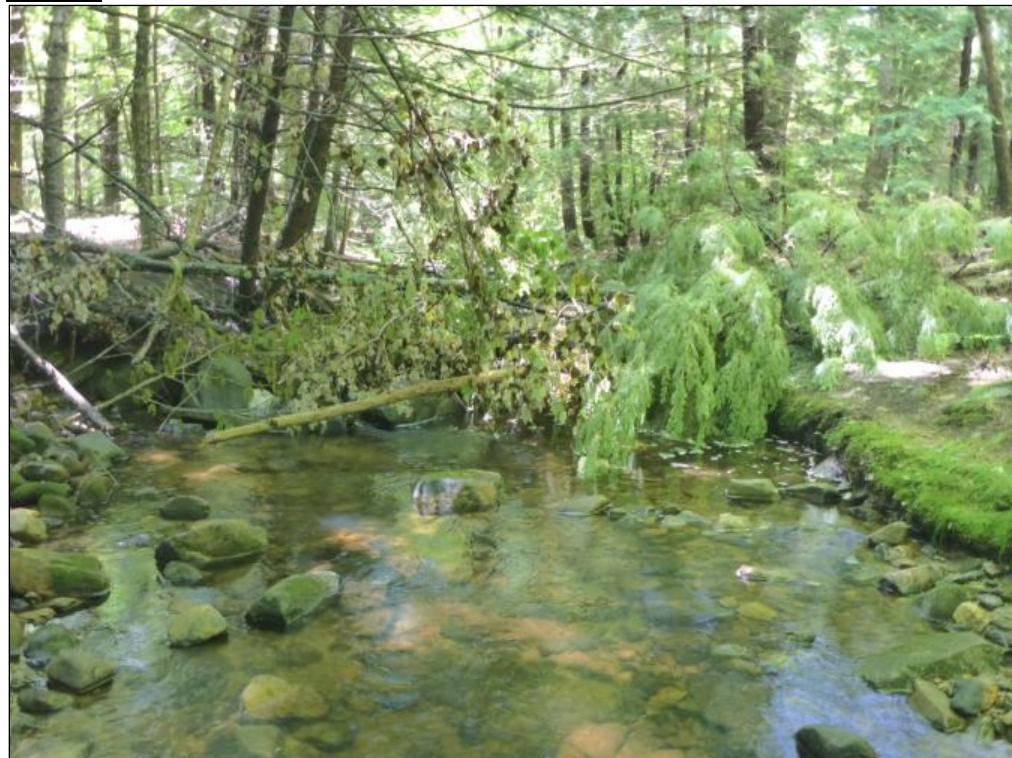
Photo 3:

Installation Site 30: N 43.54919°, W -71.35808°. One eastern hemlock and one red maple were added to this location.

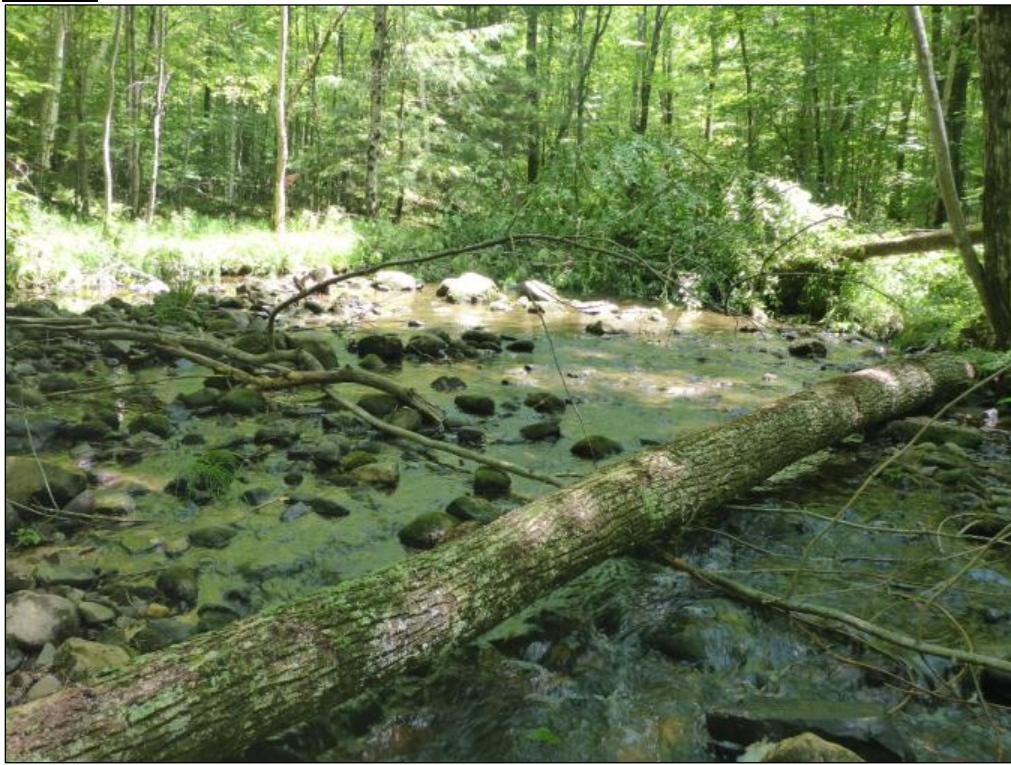
Photo 4:

Installation Site 37: N 43.55024°, W -71.36188°. One eastern hemlock, one yellow birch, one linden, and one american elm were added to this location.

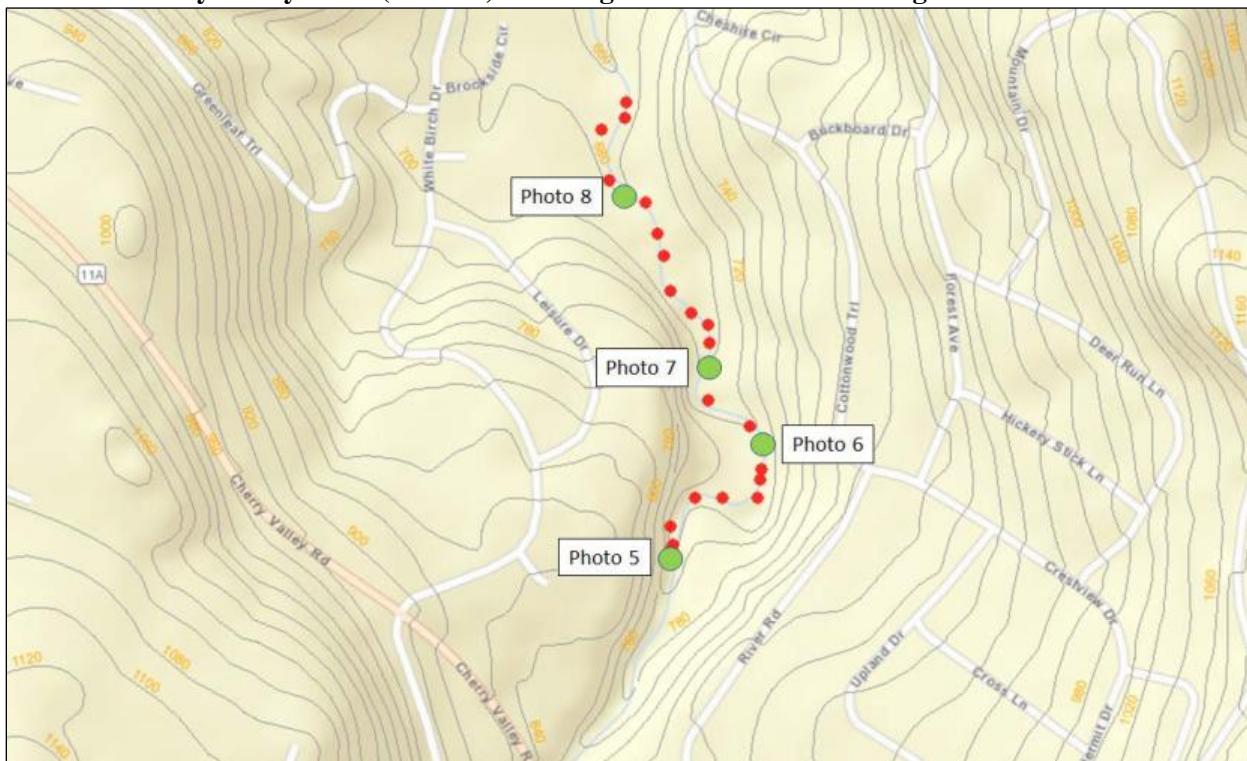
Reach 2: Cherry Valley Road (Rt. 11A) Crossing to Silver Street Crossing

The above map shows the locations of installations 38-62 (red & green dots), located on the Gunstock Acres Common Property Trust property reach of Poorfarm Brook. Green dots correspond to the below photographs.

This 4,700-foot reach of Poorfarm Brook is located on the Gunstock Acres Common Property Trust property, with an average bankfull width of 30.1 feet. Along this reach, a total of 25 large-wood structures were installed, using trees with an average DBH of 21.7cm. With concern regarding the possibility of wood mobilization during high-flow events within this section of Poorfarm Brook, large-wood structures were not installed within 500 feet upstream of the Silver Street crossing. Large-wood structures were added to this reach beginning approximately 1,000-feet downstream of the Cherry Valley Road crossing, due to a steep cascade and private parcels directly abutting the brook. The substrate of this reach consists of a mix of boulders and large cobbles, which create natural step-pool hydraulics. Large-wood structures were added to sections devoid of large-wood, with the goal of creating aquatic habitat and reengagement with surrounding floodplains during high flows.

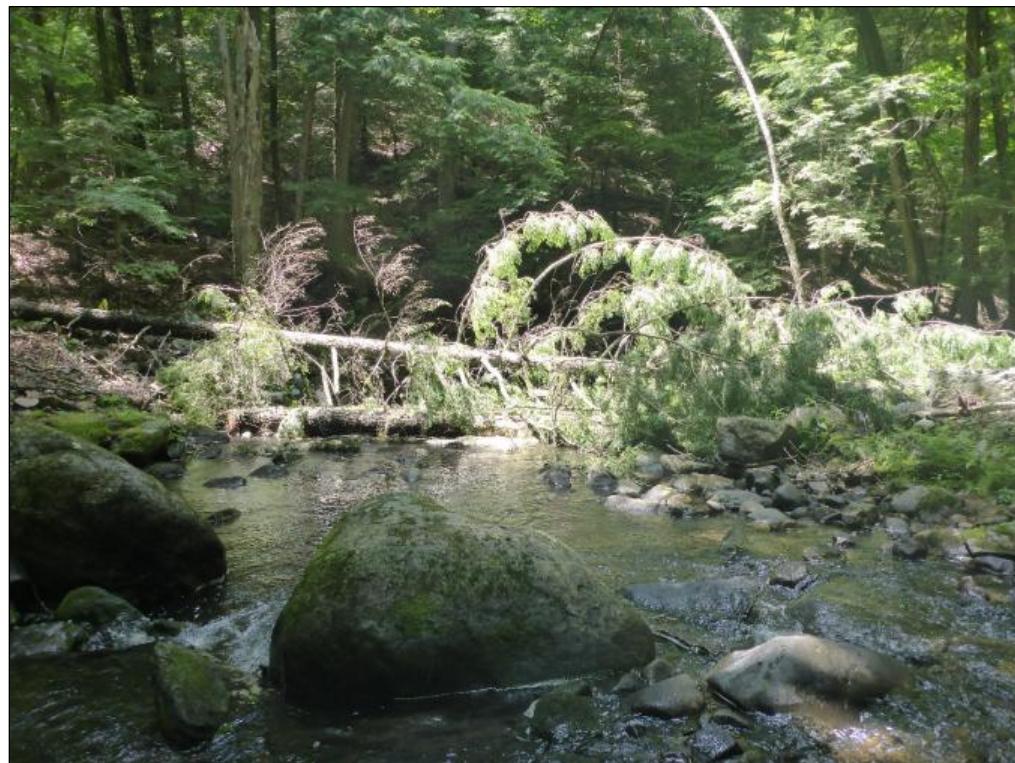
Photo 5:

Installation Site 38: N 43.55814°, W -71.36194°. One eastern hemlock was added to this location.

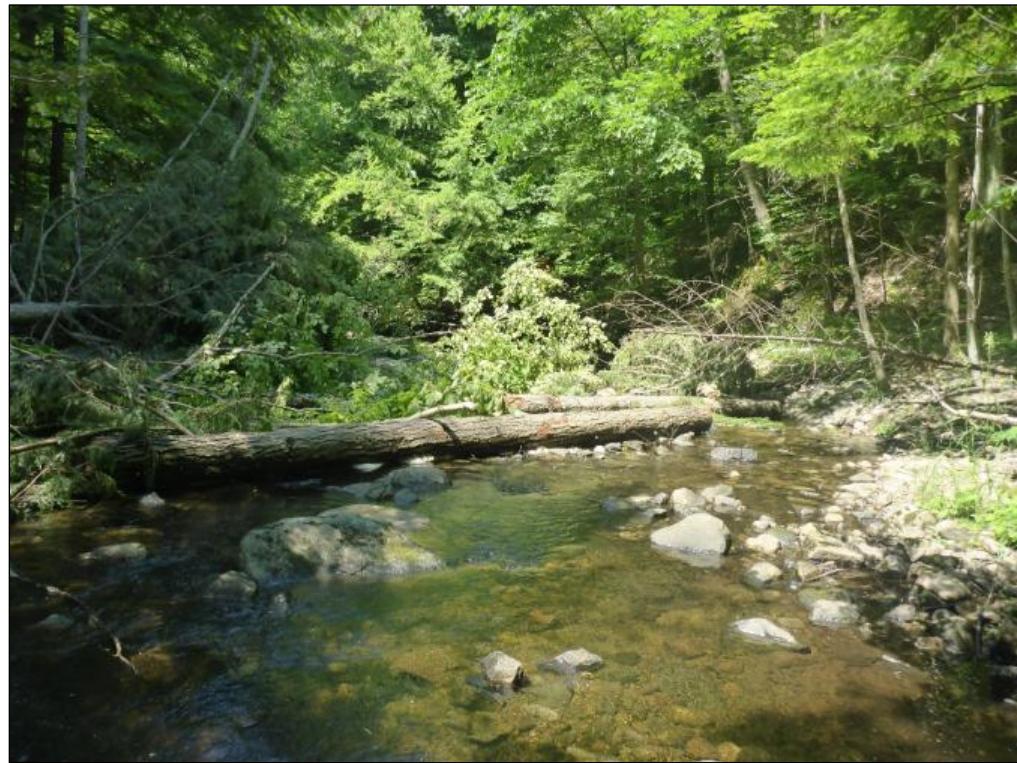
Photo 6:

Installation Site 47: N 43.55946°, W -71.36046°. One eastern hemlock and one beech were added to this location.

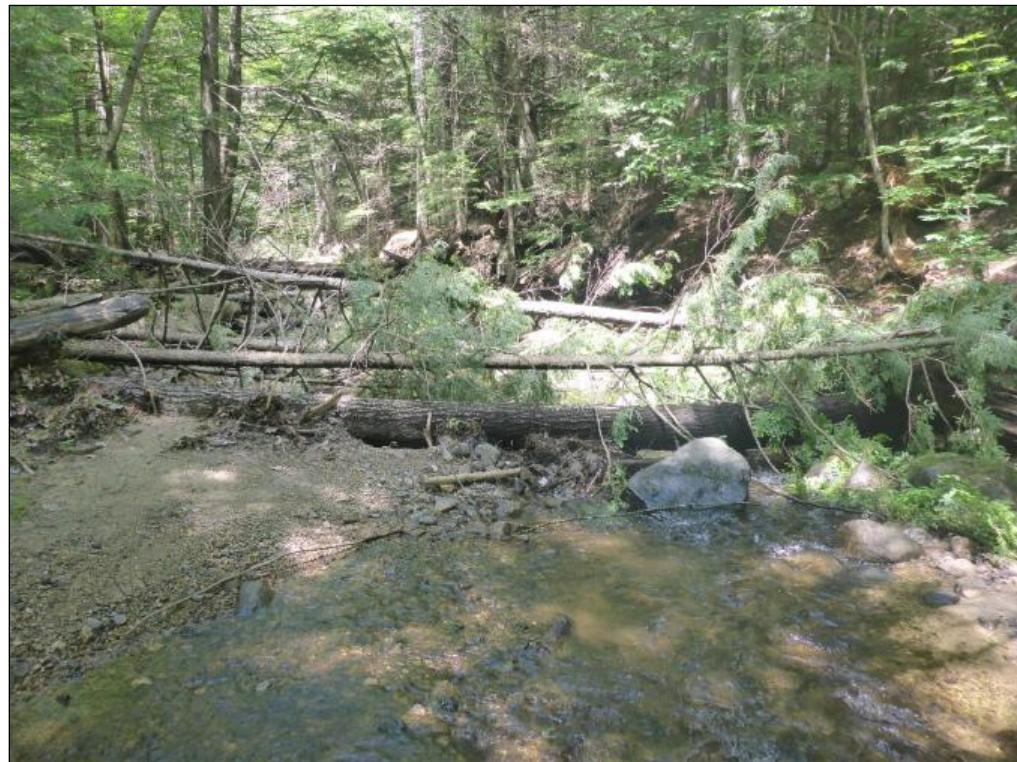
Photo 7:

Installation Site 50: N 43.56034°, W -71.36129°. Three eastern hemlock were added to this location.

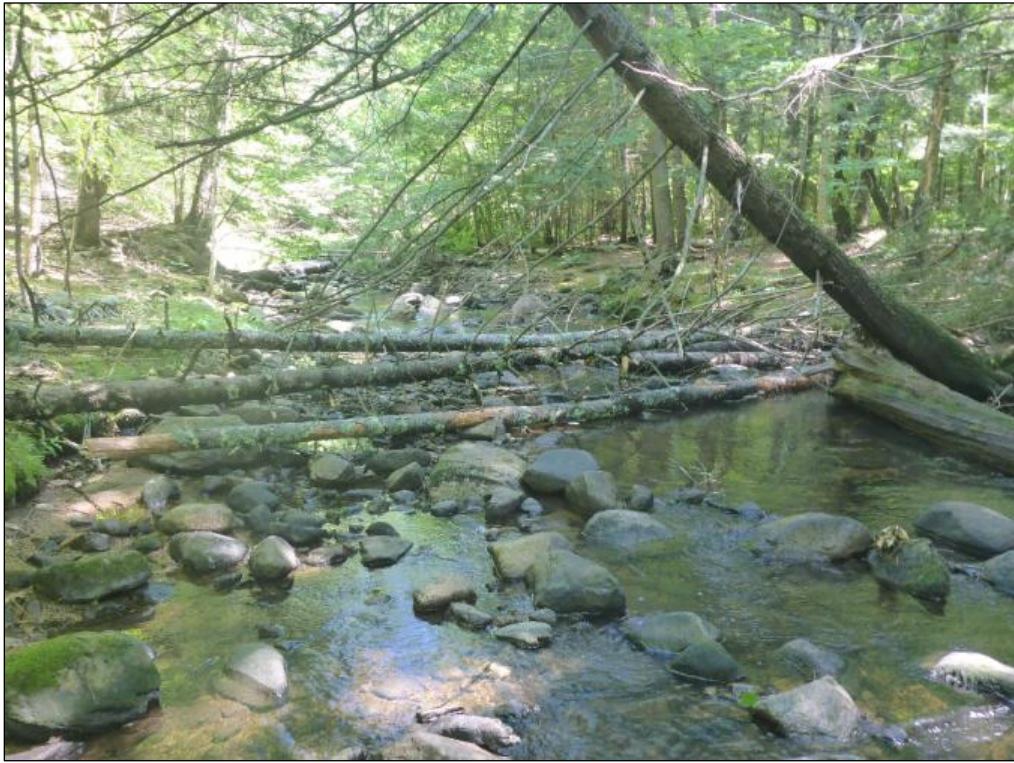
Photo 8:

Installation Site 58: N 43.56243°, W -71.36277°. Two eastern hemlock were added to this location.

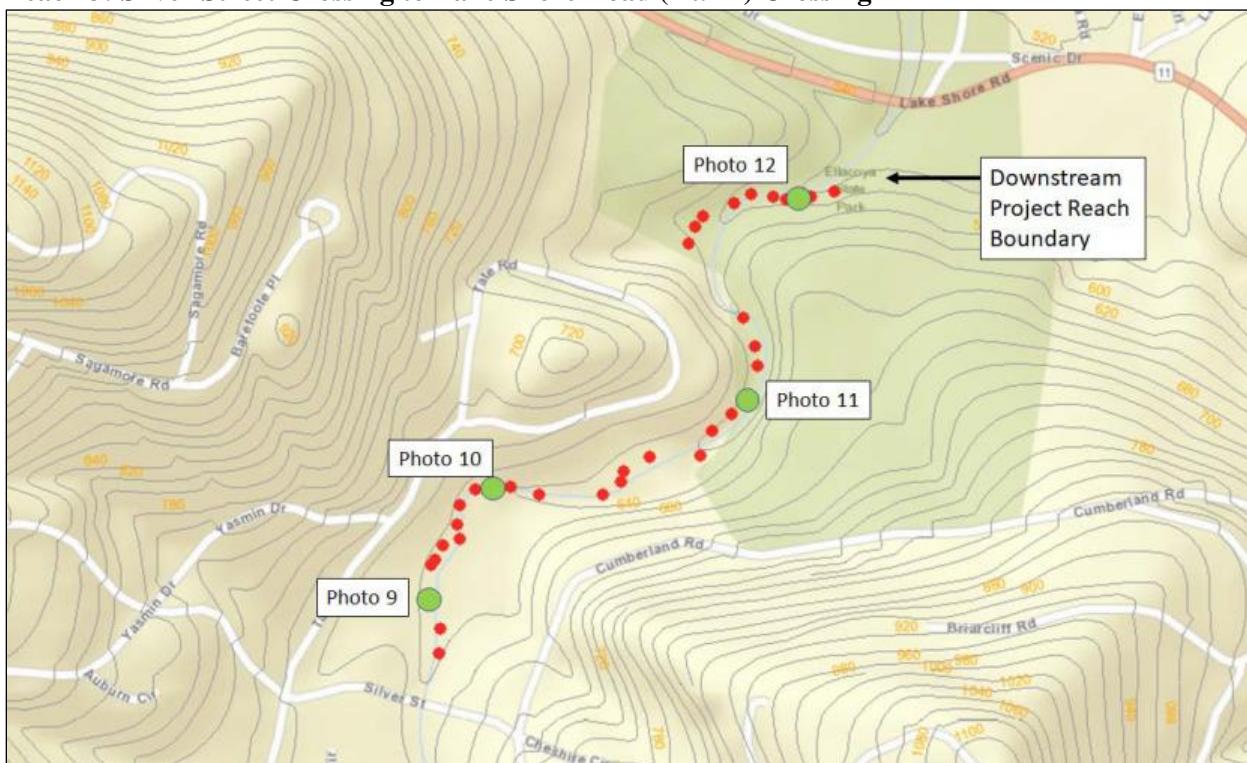
Reach 3: Silver Street Crossing to Lake Shore Road (Rt. 11) Crossing

The above map shows the locations of installations 63-96 (red & green dots), located on the Gunstock Village Water District property & Ellacoya State Park reach of Poorfarm Brook. Green dots correspond to the below photographs.

This 4,300-foot reach of Poorfarm Brook is located on the Gunstock Village Water District & Ellacoya State Park property, with an average bankfull width of 30 feet. Along this reach, a total of 34 large-wood structures were installed, using trees with an average DBH of 21.3cm. With concern regarding the possibility of wood mobilization during high-flow events within this section of Poorfarm Brook, large-wood structures were not installed within 500 feet upstream of the Lake Shore Road (Route 11) crossing. Although lacking, this reach of Poorfarm Brook featured the most naturally occurring instream large-wood. Additional large-wood was added to existing natural instream structures with the goal of increasing beneficial hydraulics, encouraging the development of pools and riffle reaches.

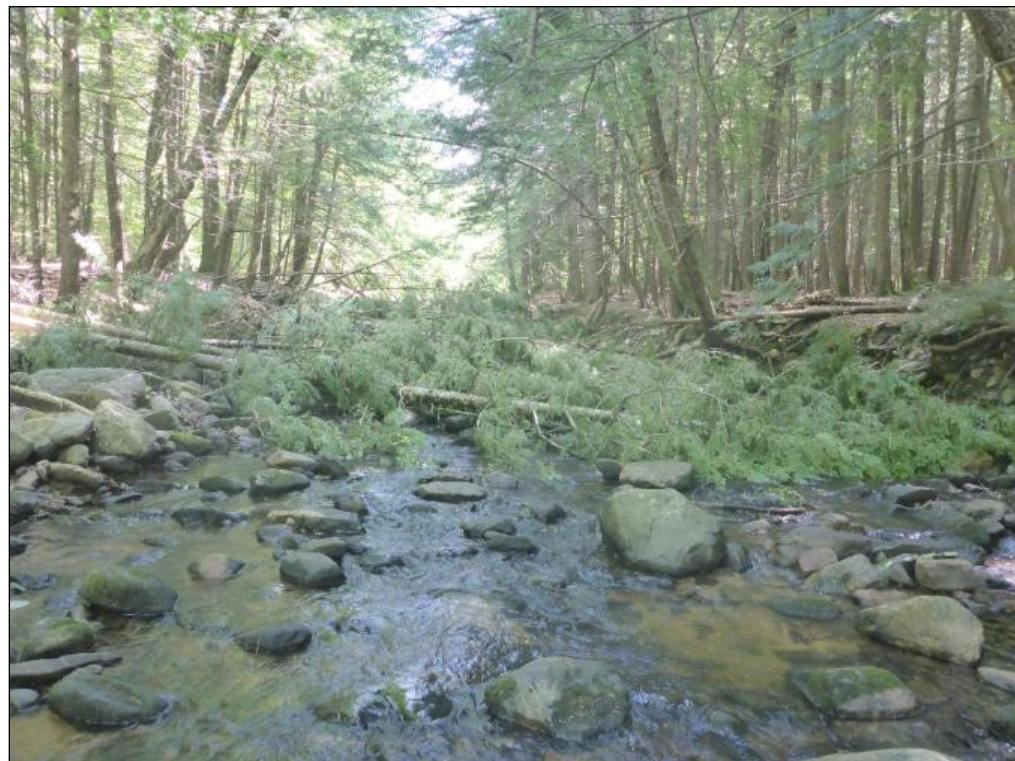
Photo 9:

Installation Site 65: N 43.56625°, W -71.36320°. Four eastern hemlock were added to this location.

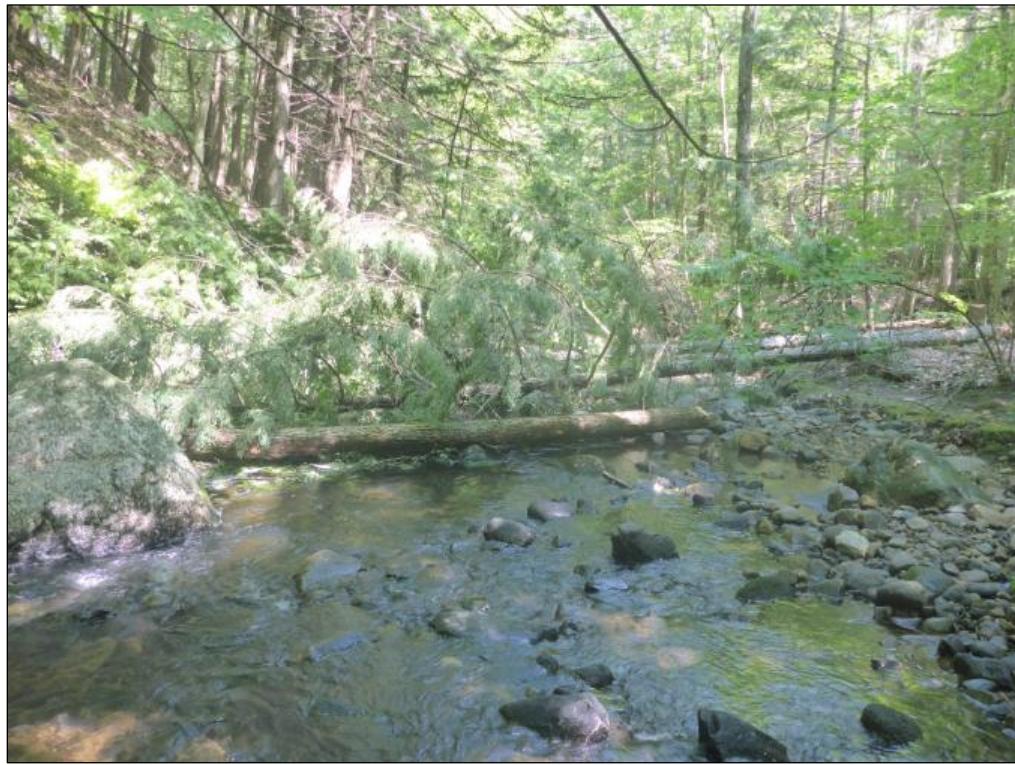
Photo 10:

Installation Site 73: N 43.56759°, W -71.36213°. One eastern hemlock and one red maple were added to this location.

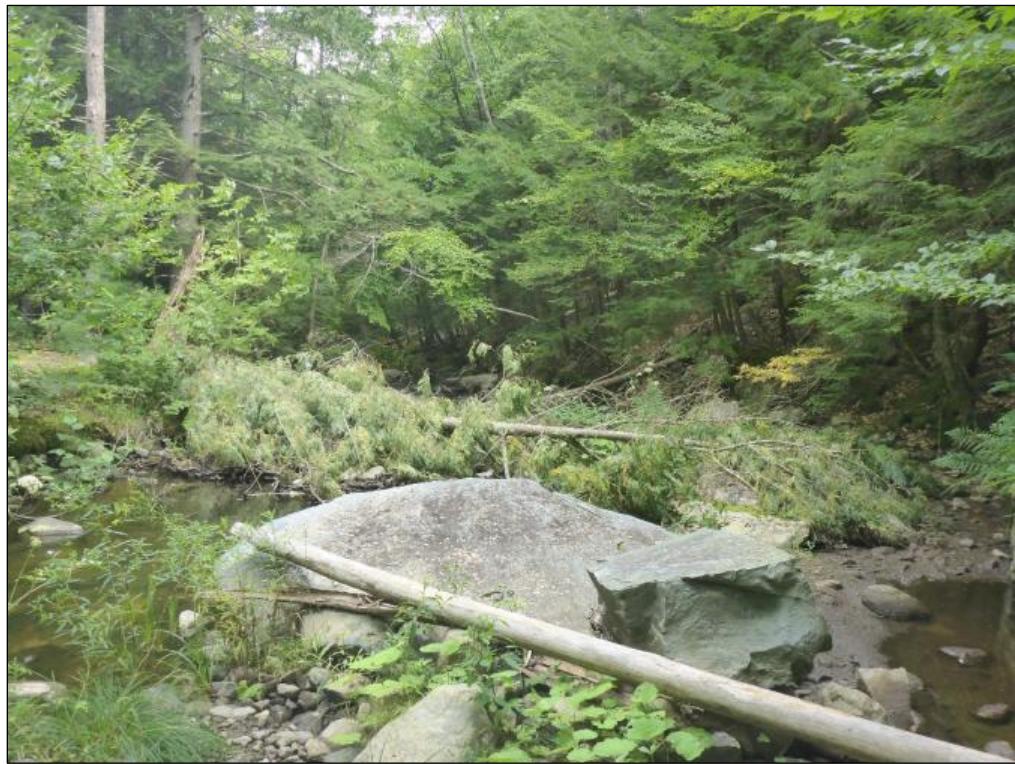
Photo 11:

Installation Site 83: N 43.56861°, W -71.35796°. Two eastern hemlock were added to this location.

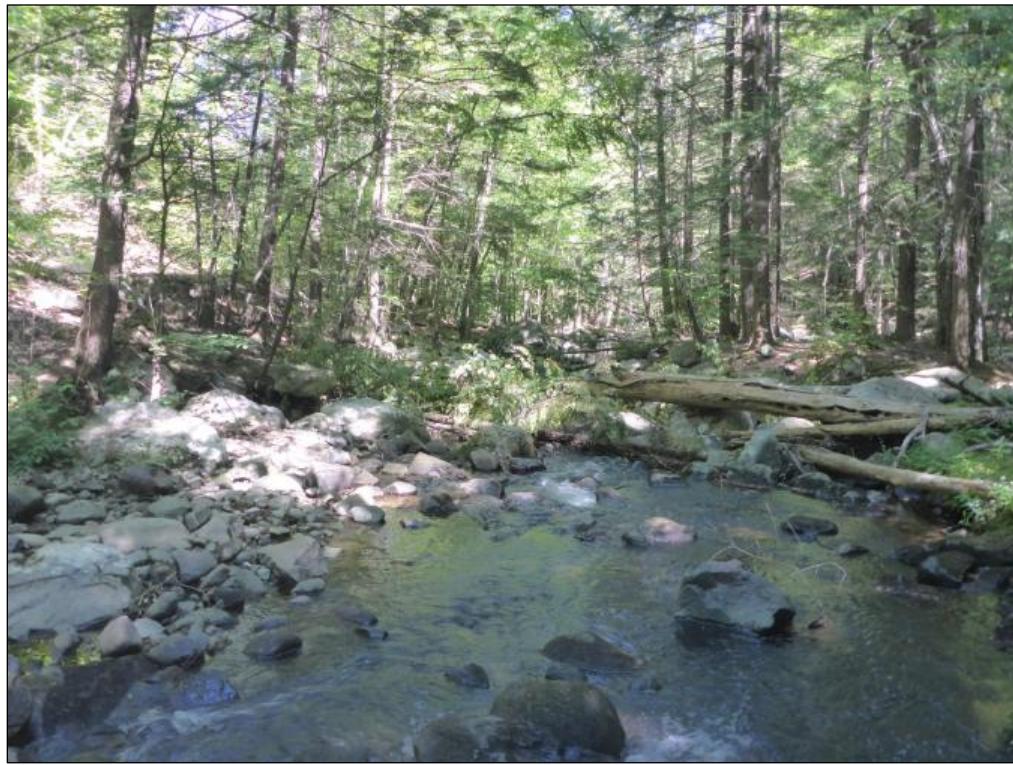
Photo 12:

Installation Site 94: N 43.57103°, W -71.35706°. One eastern hemlock and one black birch were added to this location.
